# National Pollutant Discharge Elimination System Municipal Separate Storm Sewer System Permit

## FY20 Annual Report

July 1, 2019 to  
June 30, 2020

*Montgomery County, Maryland*

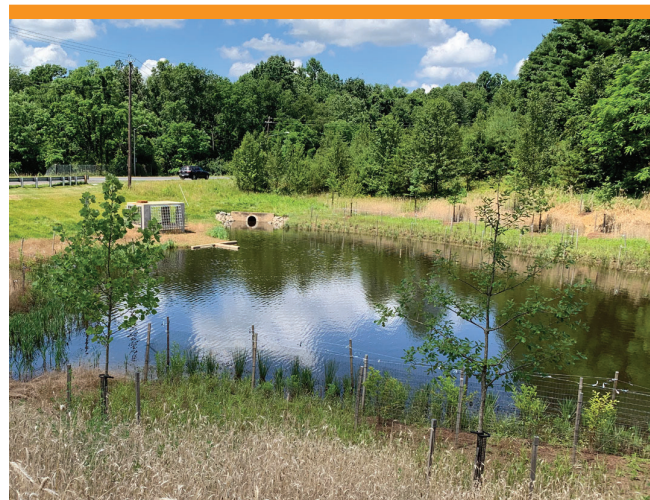
Watkins Meadow Pond Retrofit – After Construction

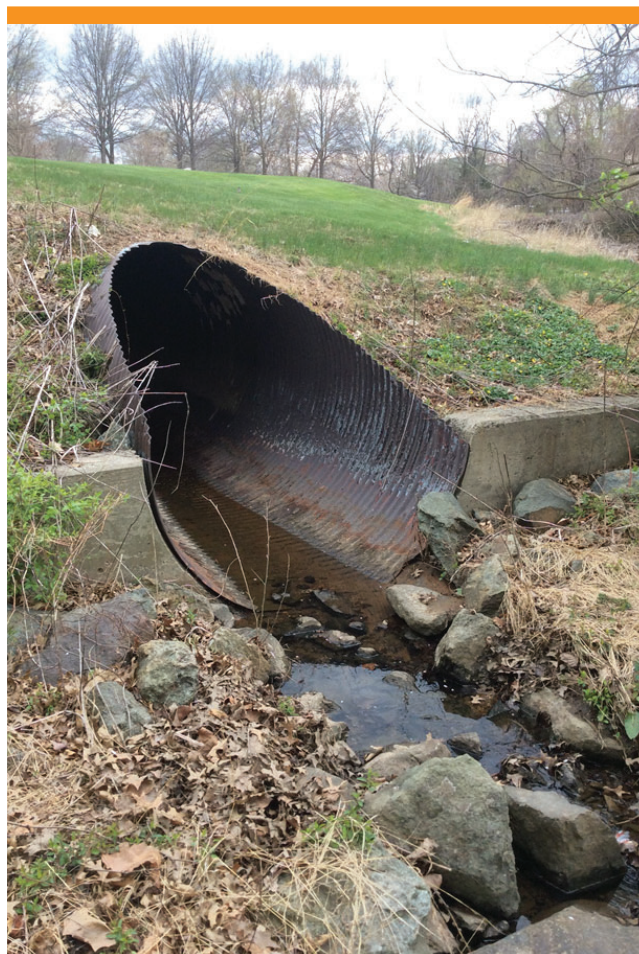
Outfall with Dry-Weather Flow

Of the 46 outfalls with dry-weather flows, 5 had suspicious discharge. Of these, 1 was determined to be naturally occurring and did not require follow up, and 2 observed no further suspicious discharge. Another was traced to a stormwater facility and the issue was referred to the DEP, which scheduled the facility for cleaning. Finally, 1 discharge was traced to a sediment control pond for the Purple Line construction project and was fixed. The remaining 41 outfalls that had dry-weather flow during the initial visit did not exhibit abnormal water chemistry parameters, visual characteristics, odor issues, or unusual vegetative growth and were, therefore, classified as groundwater discharge.

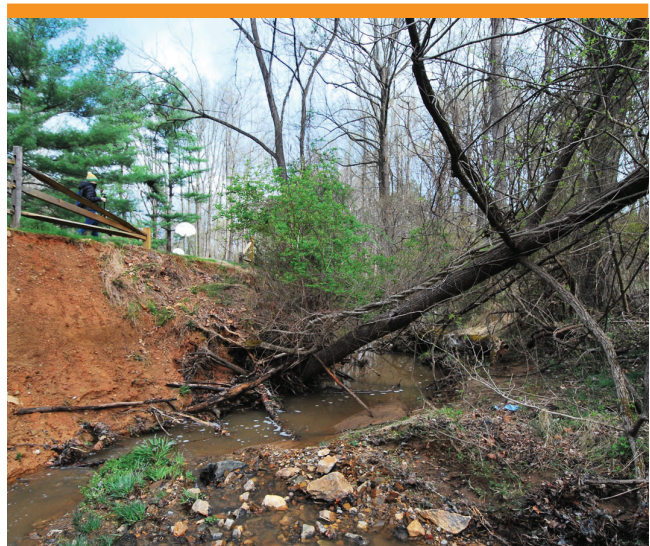
Falls Reach Stream Before

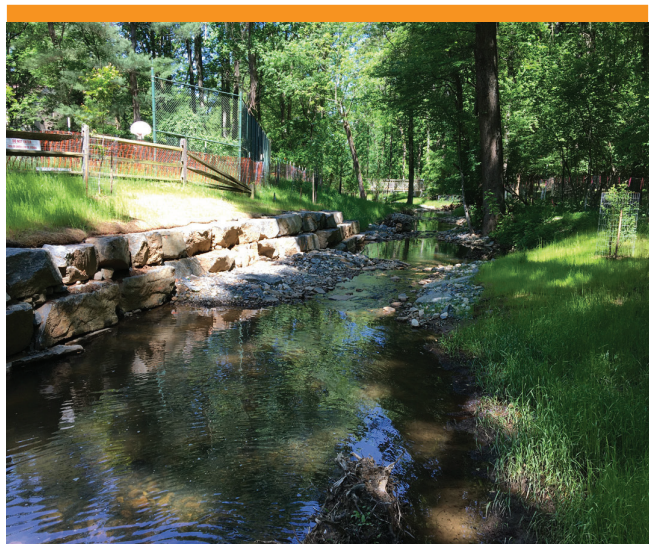
Falls Reach Stream After

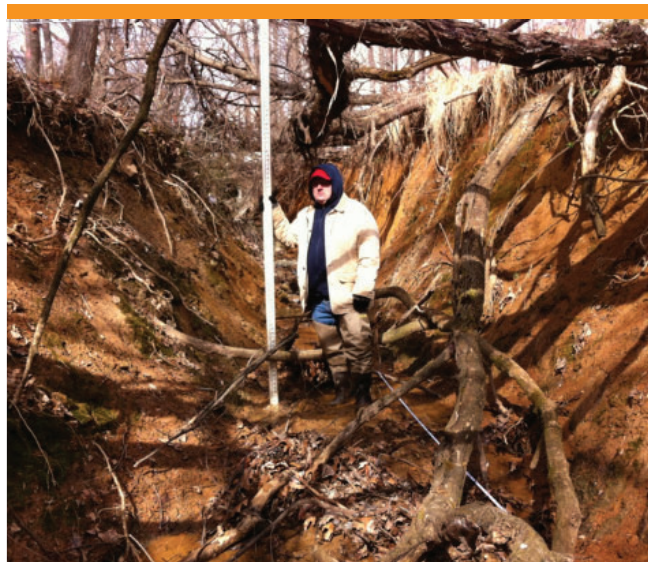
Upstream View of Sligo Creek, Breewood Tributary, Study Area 1, Pre-Restoration (2013)

Monitoring the Breewood Tributary Watershed is intended to generate information on the effectiveness of an intensive watershed restoration in improving water quality and stream conditions. The study design focuses on comparing conditions before the project with conditions after the completion of restoration efforts. Monitoring of the watershed began in 2009. Various projects were installed from 2014 through 2018. During this period, data collected reflect transitional conditions and construction impacts. Beginning in 2019, the data provide information on the completed watershed restoration. This data can be compared with data collected between 2009 and 2014 to evaluate the effectiveness of the overall effort. Preliminary analysis of the project is as follows:

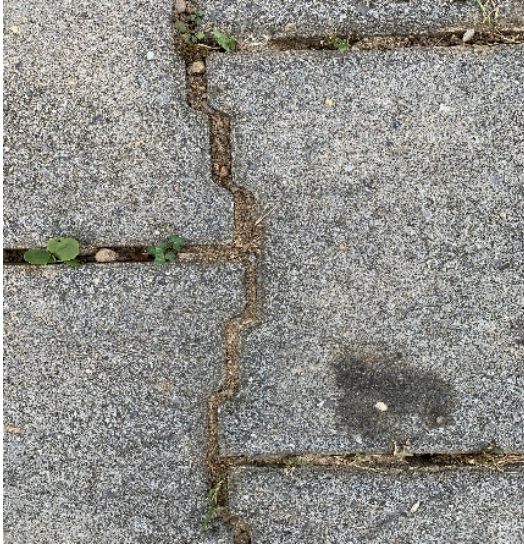
***Figure III.E.2a. PavéDrain (Sligo Park Hills) before Cleaning***

During FY20, DEP worked with the County Department of Transportation (DOT) to issue a task order for a DOT maintenance contract to vacuum 302,826 square feet of pervious pavement (concrete and PaveDrain) at several County-owned buildings, sidewalks, and parking pads in the ROW. Inlets associated with the PaveDrain were cleaned in all 22 locations. A new approach to PaveDrain maintenance included using an air space to remove debris clogging the open joint system; this was an efficient and cost-saving approach to cleaning this specific type of pervious pavement. These facilities are functioning properly, and the partnership between DEP and DOT has eased ongoing maintenance.

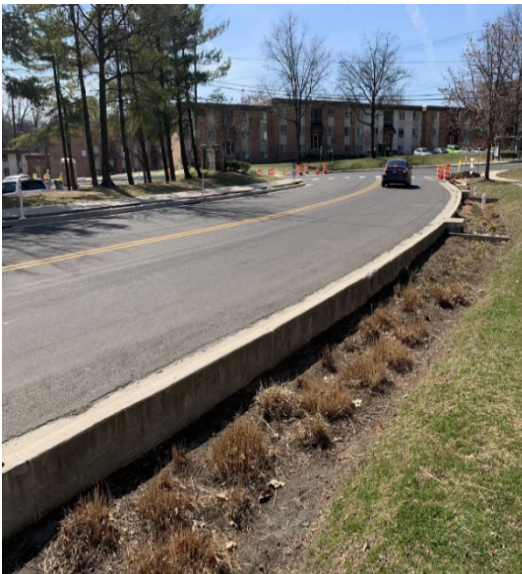
***Figure III.E.3a. White Oak LID “Green Street” before Redesign Comprising Primarily Grasses***

During FY20, DEP renovated several “Green Street” BMPs in the White Oak community. The new planting approach offers increased pollinator benefit, stormwater control, and beautification with four seasons of interest. This dense planting also reduced the open space between plants for decreased weed invasion and maintenance efforts.

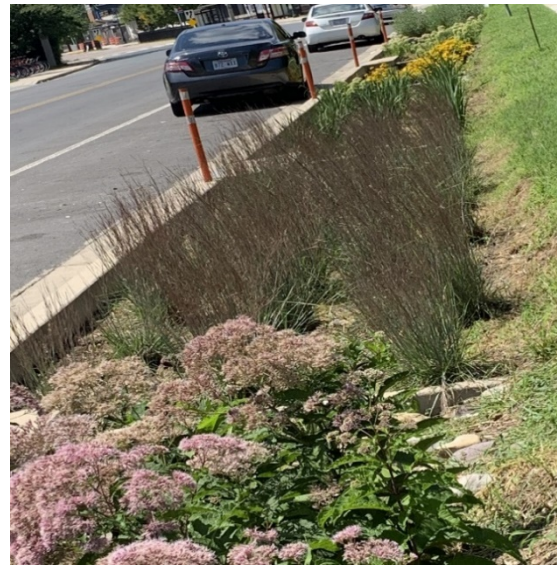
***Figure III.E.3b. White Oak LID “Green Street” after Redesign with Increased Plant Diversity and Aesthetics***

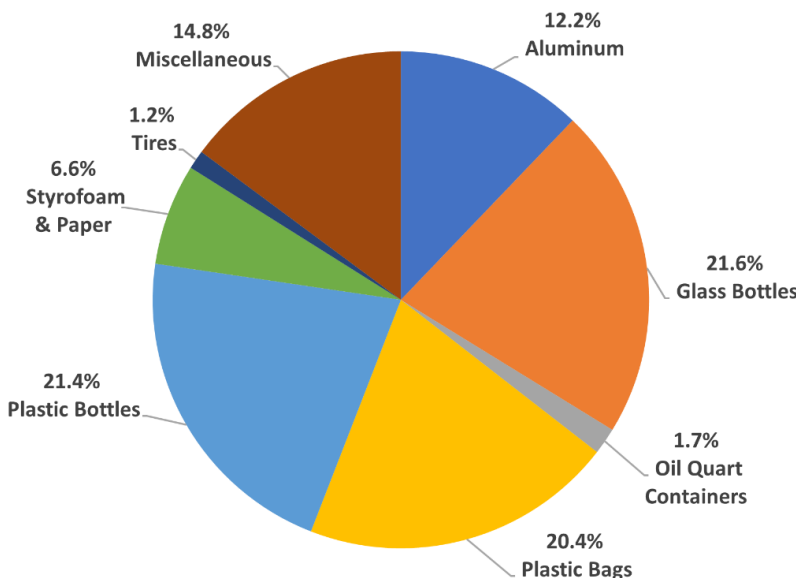
**Figure III.E.5. Trash Collected from Stormwater Ponds by Weight in FY20**

Recyclable materials (aluminum, glass and plastic bottles) made up 55.2 percent of all trash (non-organic debris) collected. Over the past 10 years, there has been a shift away from glass bottles and a corresponding increase in plastic bottles. However, in FY20, glass bottles made up 21.6 percent and plastic bottles made up 21.4 percent by weight of the trash items collected. (Figure III.E.5). More pounds of glass bottles were collected (704) than any of the other categories of trash.

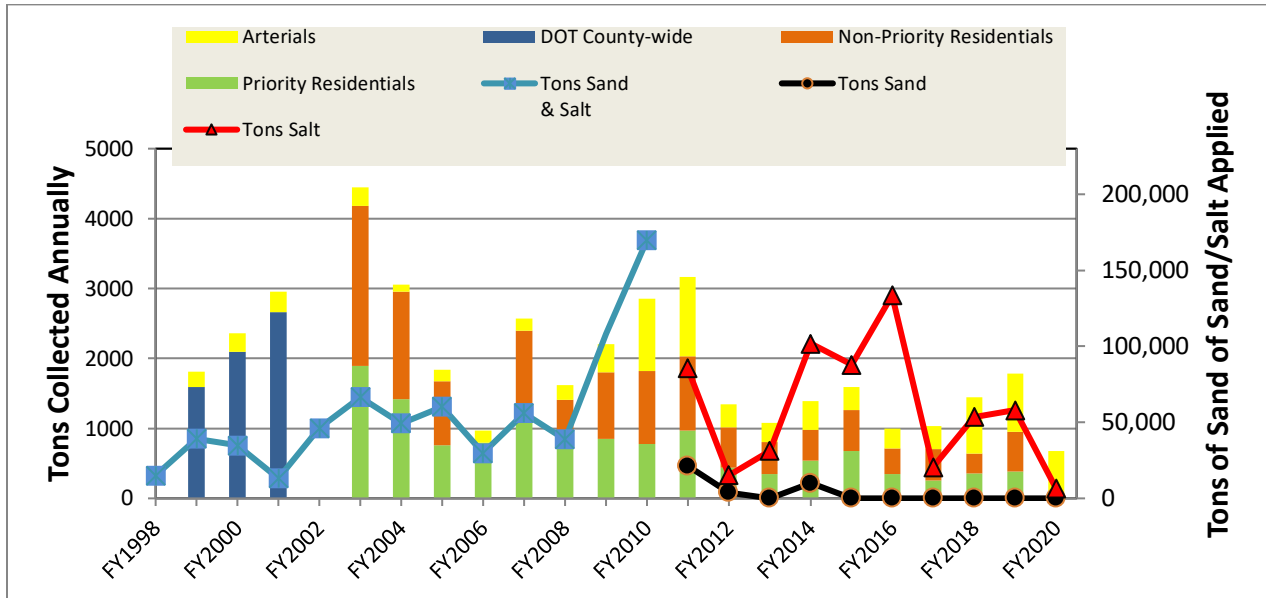
**Figure III.E.8. Tons of Material Applied during Winter Activities and Collected by Street Sweeping (FY98 through FY20)**

Figure III.E.8 shows tons of materials removed annually by street sweeping from FY99 to FY19 in the priority and nonpriority residential areas and arterials. This figure also illustrates tons of salt, sand and salt, and sand only tons applied during the winter period. From FY98 through FY10, data on salt and sand applied during the winter period are presented, however, data for FY09 were not reported. Starting in FY11, separate data for salt and sand application sand were available and also presented on this figure. Salt application was relatively high between FY14 and FY16 but has been lower since. Sand has not been widely used since FY14 (Table III.E.22). As previously stated, no residential sweeping was conducted in FY20, thus, only arterial sweeping is shown on Figure III.E.8.

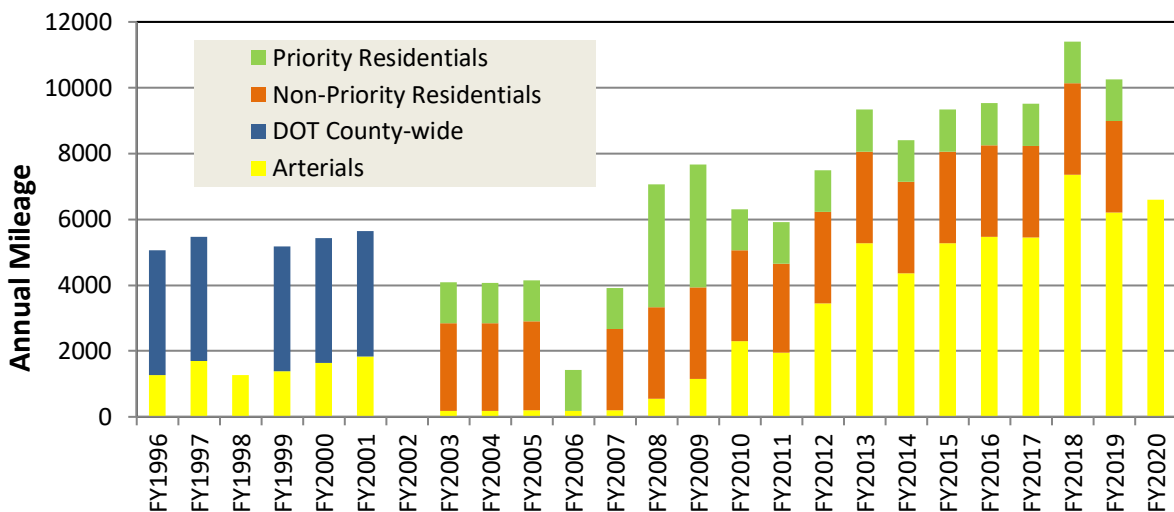
**Figure III.E.9. Annual Montgomery County Street Sweeping Mileage, FY96 through FY20**

Figure III.E.9 shows the annual street sweeping mileage from FY96 through FY20. Data from this time period represent arterials and DOT countywide area. Starting in FY03, mileage of street sweeping on residential routes, both priority and nonpriority, along with arterials are presented. As previously stated, no residential sweeping was conducted during FY20 (Section E.6.a.i).

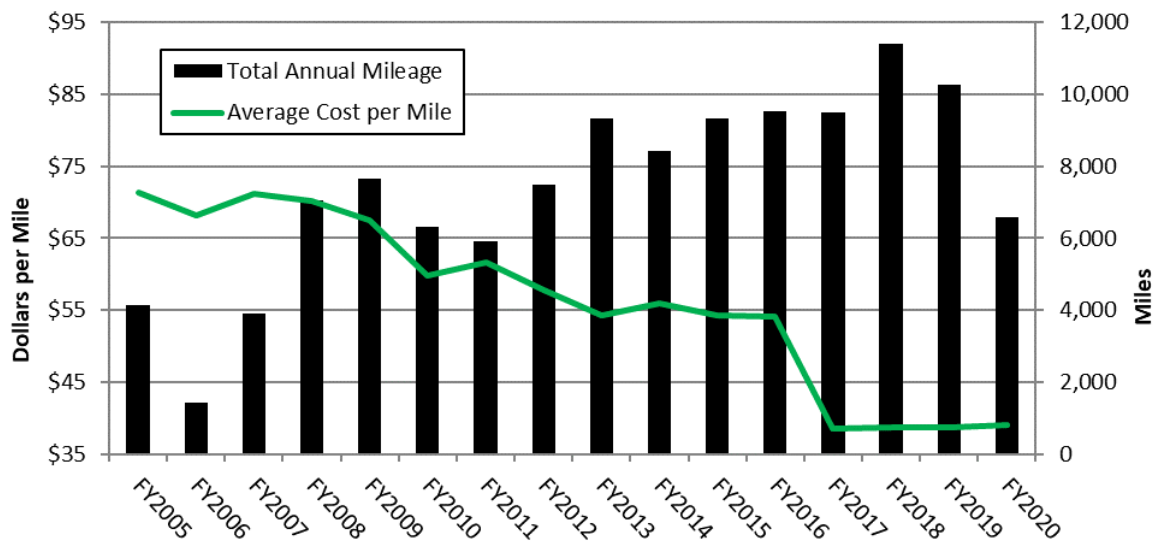
**Figure III.E.10. Montgomery County Street Sweeping Mileage and Average Cost, FY05 through FY20**

Figure III.E.10 shows the annual street-sweeping mileage and average cost per mile for the program from FY05 through FY20. The cost of the program decreased over time with a notable decline in FY17 mainly due to a new contractor.

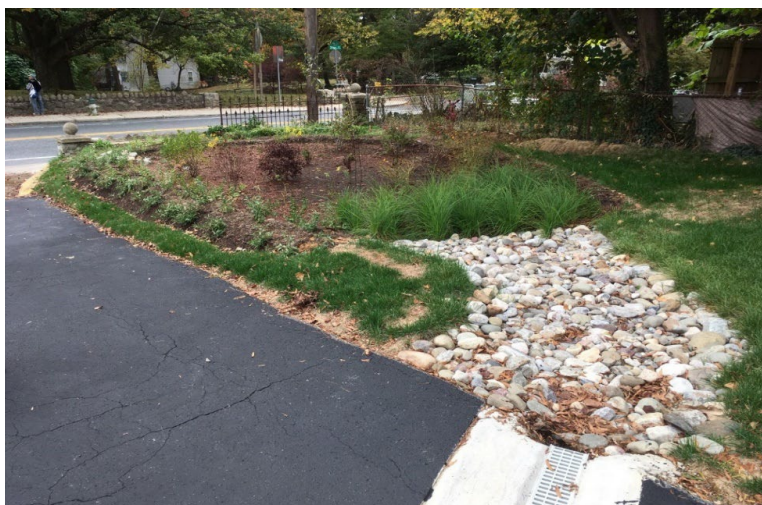
**Figure III.E.17. Adventist Community Services Rain Garden**

- **Adventist Community Services and Tartan Ridge HOA by Anacostia Riverkeepers**—These two projects involved installing porous pavement, planting trees, installing a rain garden (Figure E.III.17), and conservation landscaping to address problematic sheet flow and erosion on both properties. Details and final reports are online.<sup>11</sup>

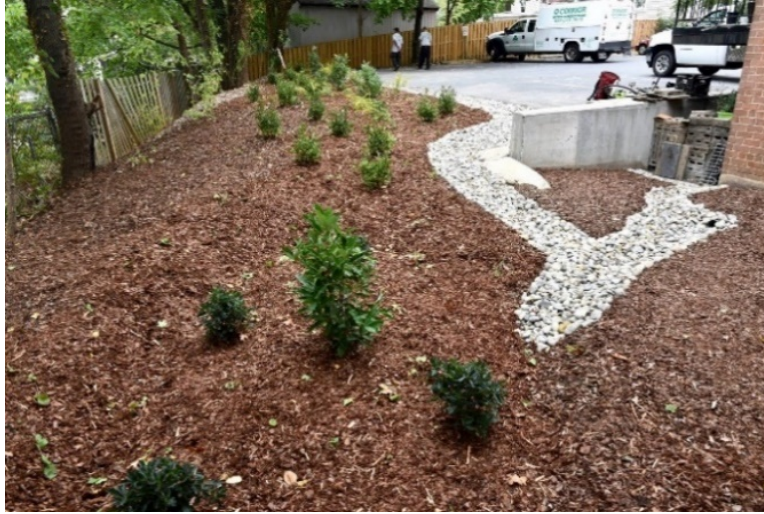
*Figure III.E.18. Conservation Landscape Demonstration at Carolyn Condominiums*

(Figure III.E.18). The project<sup>12</sup> is part of a long-term stormwater solution for this property and the residents living downslope.

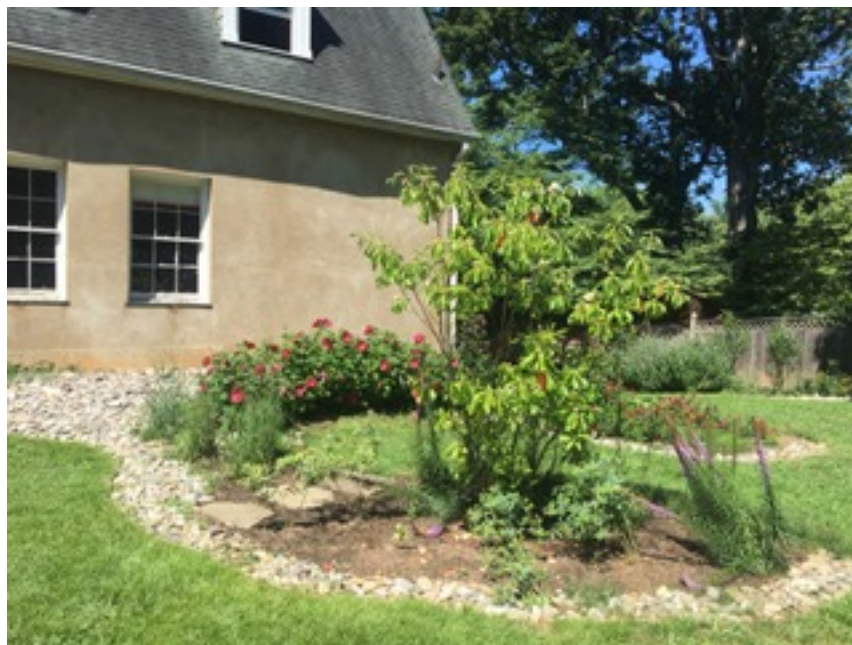
**Figure III.E.20. Conservation Landscaping at the Bannockburn Community Center**

- **Audubon Naturalist Society**—The Audubon Naturalist Society completed their design to replace their parking area with porous pavement for the next phase of their stormwater master plan.<sup>13</sup>
- **Bannockburn Community Center**—The Bannockburn Community Center completed their conservation landscaping plan to address significant stormwater flows and erosion concerns on the property and the affecting downstream neighbors (Figure E.III.20).

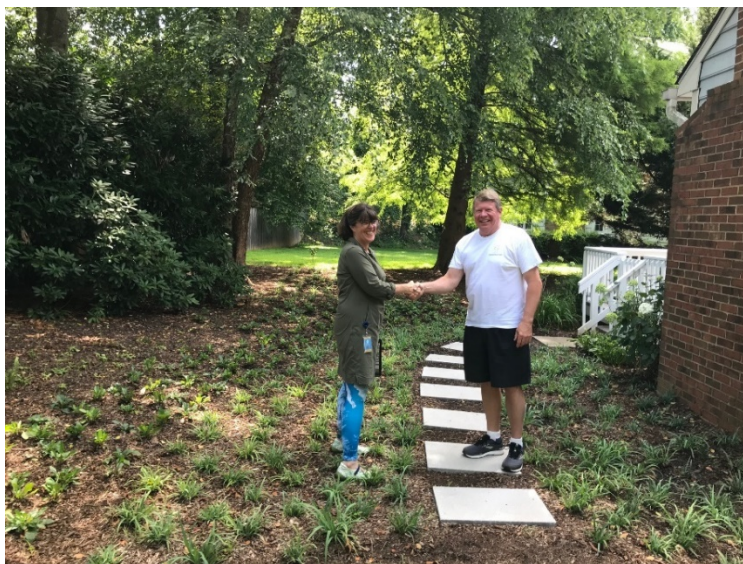
**Figure III.E.29. Successfully Completed Conservation Landscape Rewards Project**

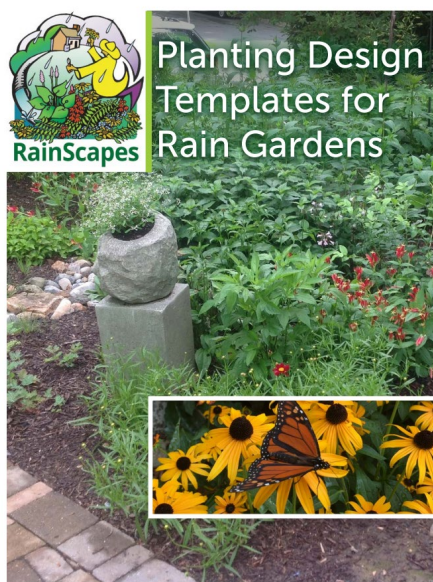
**Figure III.E.30. Planting Design Templates for Rain Gardens**

RainScapes staff provided technical assistance to most grants awarded under the Montgomery County Chesapeake Bay Trust Grants. Site assessments conducted by RainScapes provided the technical guidance and outreach support to allow grant projects to move from discussion to reality. The range of projects spanned rain gardens, drywells, conservation landscapes, and water harvesting (Figure III.E.29). Staff input included reviewing designs, overseeing installations, and supporting workshop planning and delivery. Many of these projects were congregational that started as possible rebate projects but were developed as grant proposals after DEP enlarged the scale to be more suitable as a grant. In addition to meeting and teaching, RainScapes released two new documents—*Rain Gardens Planting Design Templates* (Figure III.E.30) and *Plant Spacing Guide for RainScapes* (Figure III.E.31).
